**DEPARTMENT OF TRANSPORTATION**

Contract #: 04-0120F4Cty: SF/ALA Rte: 80 PM: 13.2/13.9File #: 69.28**WELDING INSPECTION REPORT****Resident Engineer:** Siegenthaler, Peter**Address:** 333 Burma Road**City:** Oakland, CA 94607**Report No:** WIR-018962**Date Inspected:** 14-Dec-2010**Project Name:** SAS Superstructure**OSM Arrival Time:** 700**Prime Contractor:** American Bridge/Fluor Enterprises, a JV**OSM Departure Time:** 1900**Contractor:** Zhenhua Port Machinery Company, Ltd (ZPMC), Changxing Island **Location:** Shanghai, China**CWI Name:** Zhao Chen Sun**CWI Present:** Yes No**Inspected CWI report:** Yes No N/A**Rod Oven in Use:** Yes No N/A**Electrode to specification:** Yes No N/A**Weld Procedures Followed:** Yes No N/A**Qualified Welders:** Yes No N/A**Verified Joint Fit-up:** Yes No N/A**Approved Drawings:** Yes No N/A**Approved WPS:** Yes No N/A**Delayed / Cancelled:** Yes No N/A**Bridge No:** 34-0006**Component:** TOWER Components**Summary of Items Observed:**

**SOUTH TOWER LIFT-5**

### EAST TOWER LIFT-5

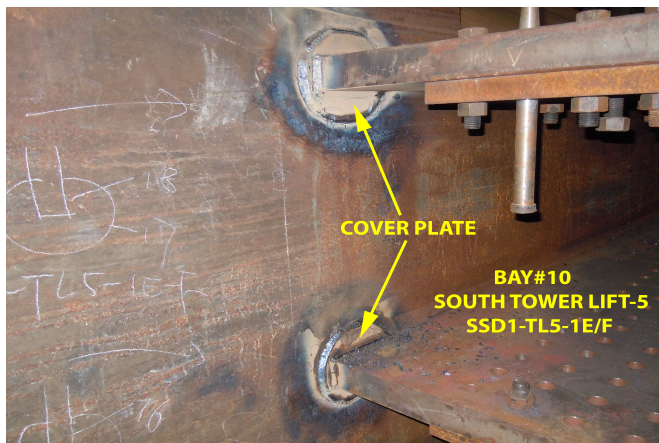
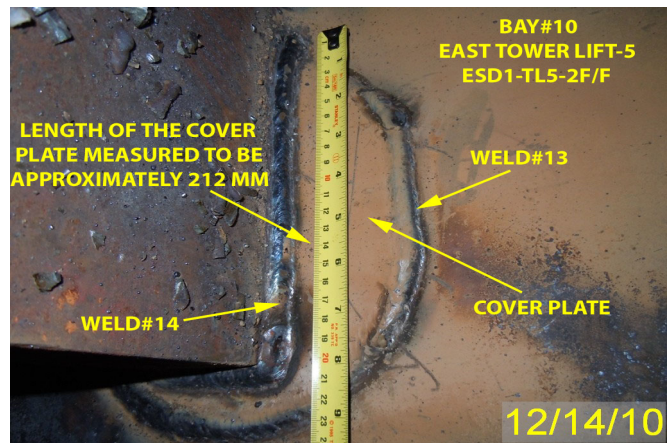
During the Caltrans Quality Assurance (QA) in-process observation on South tower lift-5 Cover plate, this QA Inspector discovered the following issue:

- ZPMC personnel welding the non-compliable cover plates to south shaft on skin 'E'.
- As per the shop drawing the required length of the cover plate is 151.4 mm.
- But length of the cover plate measured to be approximately 212 mm.
- Welds are fillet welds joining cover plate to skin 'E'.
- The weld designations are SSD1-TL5-1E/F#15; 16; 17; 18.
- This component located at fabrication Bay#11.

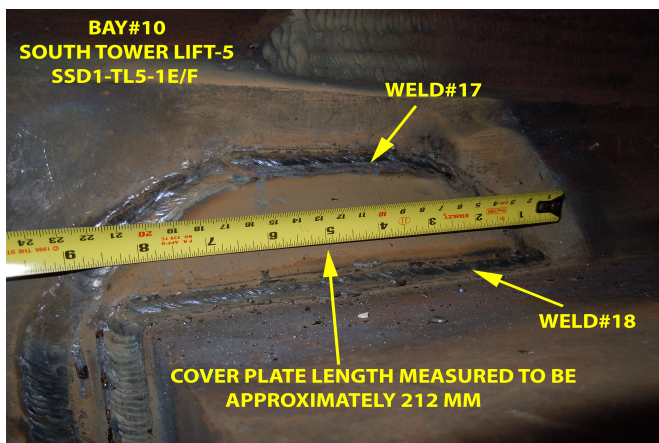
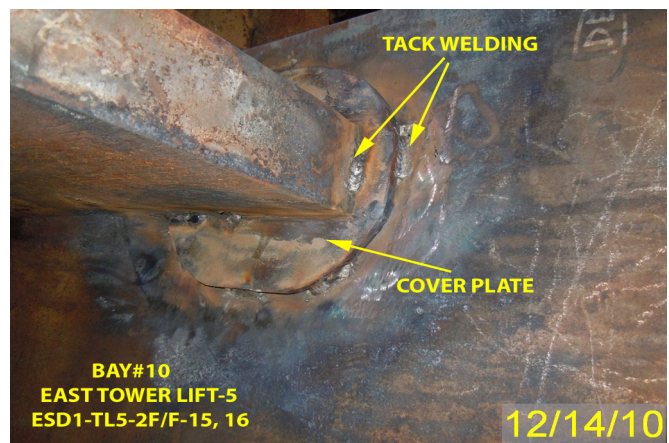
During the Caltrans Quality Assurance (QA) in-process observation on East tower lift-5 Cover plate, this QA Inspector discovered the following issue:

- ZPMC personnel welding the non-compliable cover plates to east shaft on skin 'E'.
- As per the shop drawing the required length of the cover plate is 151.4 mm.
- But length of the cover plate measured to be approximately 212 mm.
- Welds are fillet welds joining cover plate to skin 'E'.
- The weld designations are ESD1-TL5-2F/F#13; 14; 15; 16.
- This component located at fabrication Bay#11.
